**Survey and Documentation Services  
12<sup>th</sup> Street Landfill Site  
Wilmington, Delaware**

**(Schnabel Reference 00151122)**

Subject: Contract 00151122, Survey and Documentation  
Services, 12<sup>th</sup> Street Landfill Site, Wilmington,  
Delaware

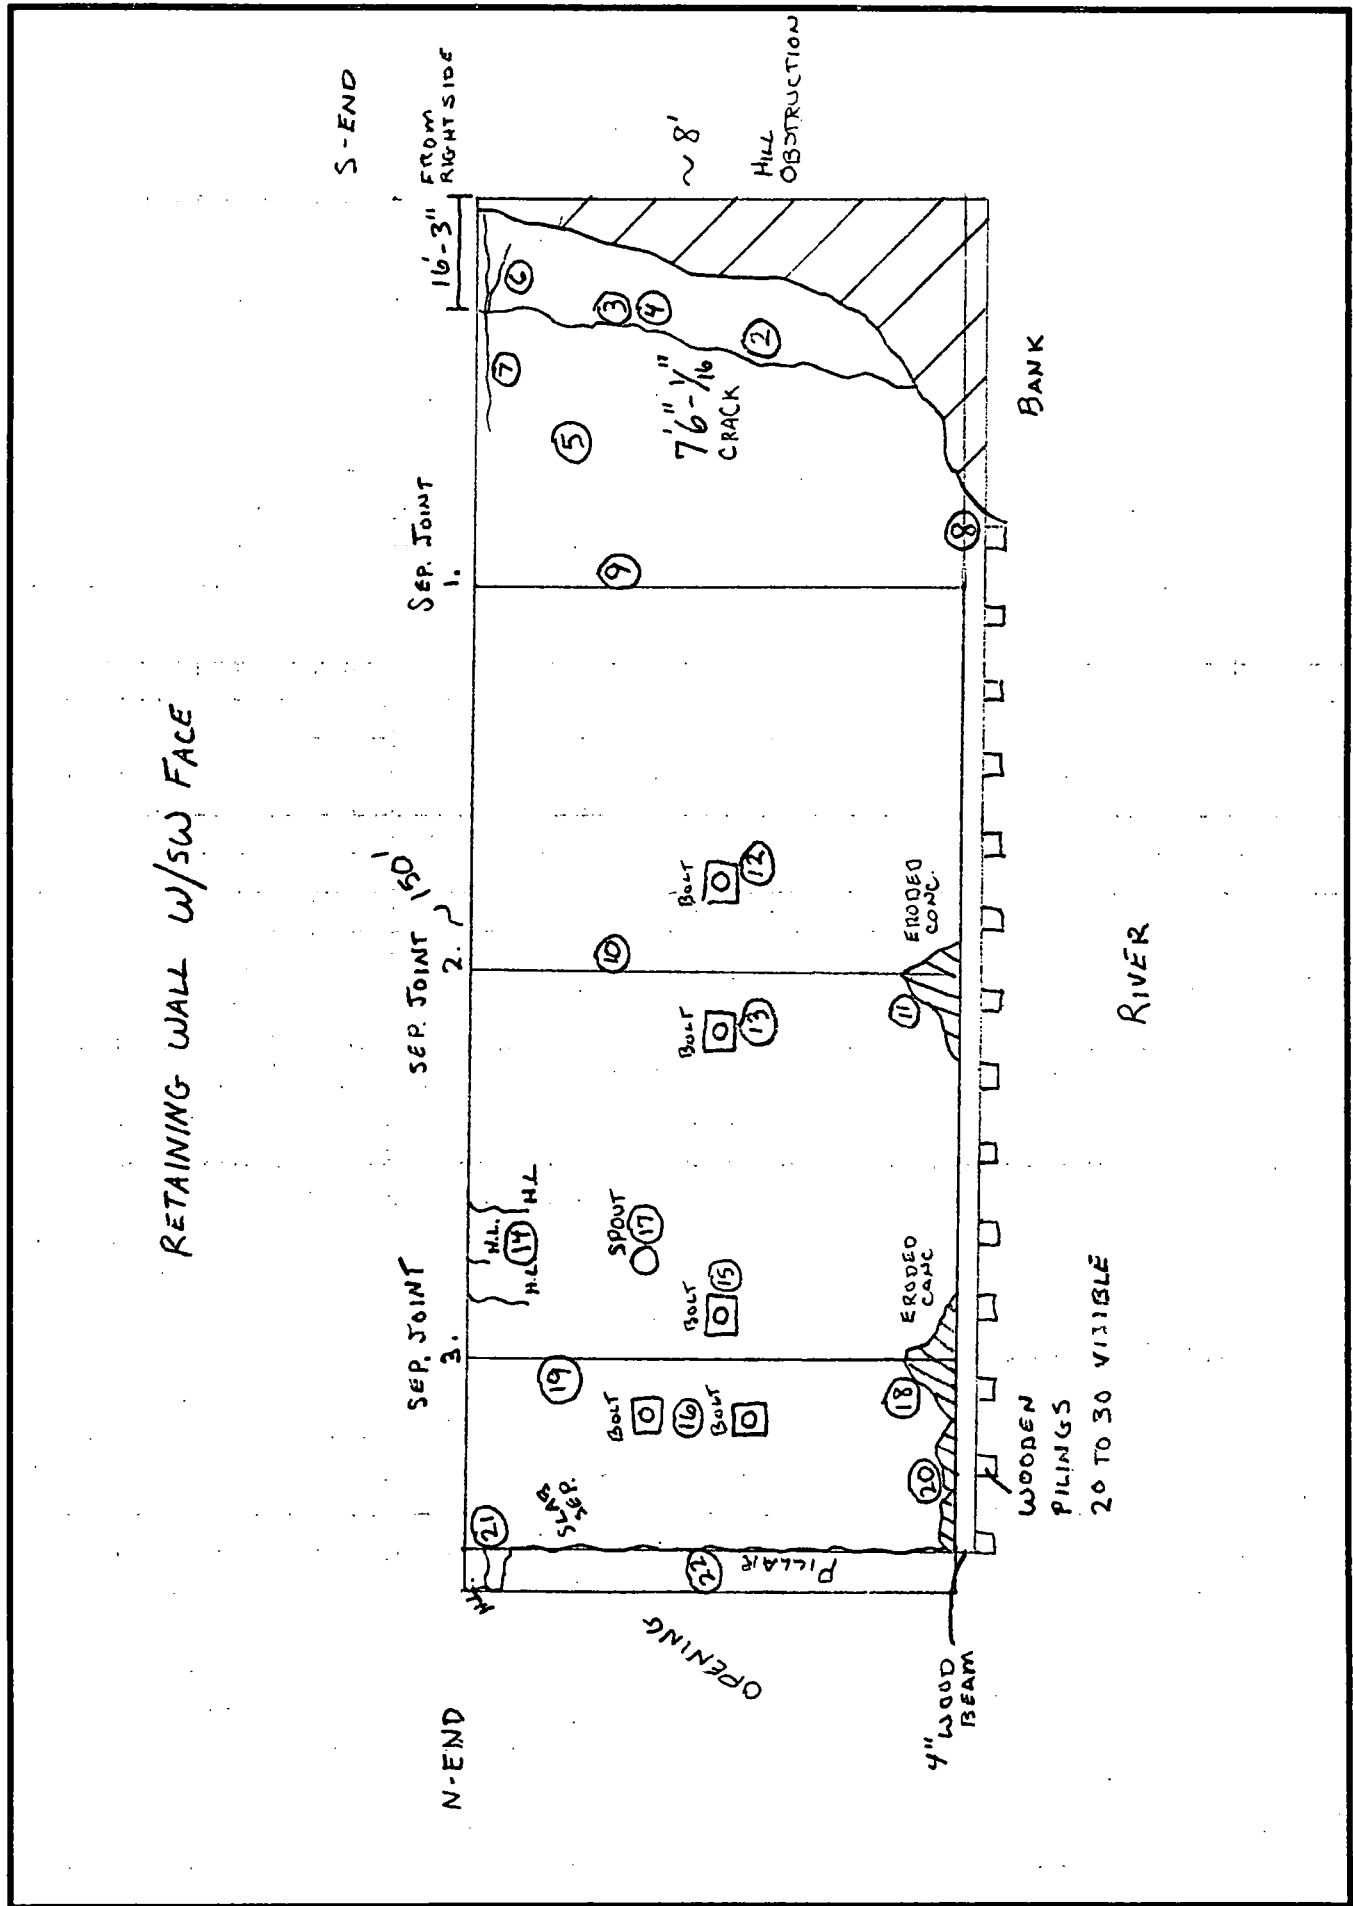
SHEET NO. 2 OF 4 ORIGINAL  
 JOB NO. ....

FOUNDATION: CONCRETE ☒ CONC. BLOCK ☐ BRICK ☐ OTHER ☐  
 HOUSE SIDING: BRICK ☐ WOOD ☐ ALUMINUM ☐ VINYL ☐ COMMENTS: CONC. EXTERIOR WALL  
 ROOF: ASPHALT SHINGLE ☐ SLATE ☐ OTHER ☒ COMMENTS: NO ROOF  
 CHIMNEY: BRICK ☐ BLOCK ☐ OTHER ☐ COMMENTS: NONE  
 NUMBER OF STORIES:                      PICTURE NO.: - 22 PICTURES TAKEN / 2 VIDEOS  
 PORCH: F S R ☐ F S R ☐ HOUSE LENGTH: 50 YD. HEIGHT: 10'  
 BROKEN GLASS: N ☐ E ☐ S ☐ W ☐ NATURE OF GROUND: ON BRANDYLINE RIVER  
 SIDEWALKS: N ☐ E ☐ S ☐ W ☐ FLAT ☐ HILLY ☐ FILL ☐  
 MORTAR JOINTS CRACKED: YES ☐ NO ☐ WATER PRESSURE: HIGH ☐ LOW ☐ MED ☐  
 WATER: CITY ☐ WELL ☐ OTHER ☐ WATER QUALITY: CLEAR ☐ MILKY ☐ RUSTY ☐  
 HOUSE FACES: N ☐ E ☐ S ☐ W ☒ BASEMENT: YES ☐ NO ☐

GUTTERS: YES ☐ NO ☐ COMMENTS: NONE  
 DOWN SPOUT: YES ☐ NO ☐ COMMENTS: NONE  
 D.S. DRAINS TO: EARTH ☐ THROUGH ☐ CATCHBASIN ☐ SEWER ☐  
 EROSION NEAR FOUNDATION WALL: YES ☒ NO ☐ COMMENTS:                       
 BUILDING SETTLED: YES ☒ NO ☐ COMMENTS:

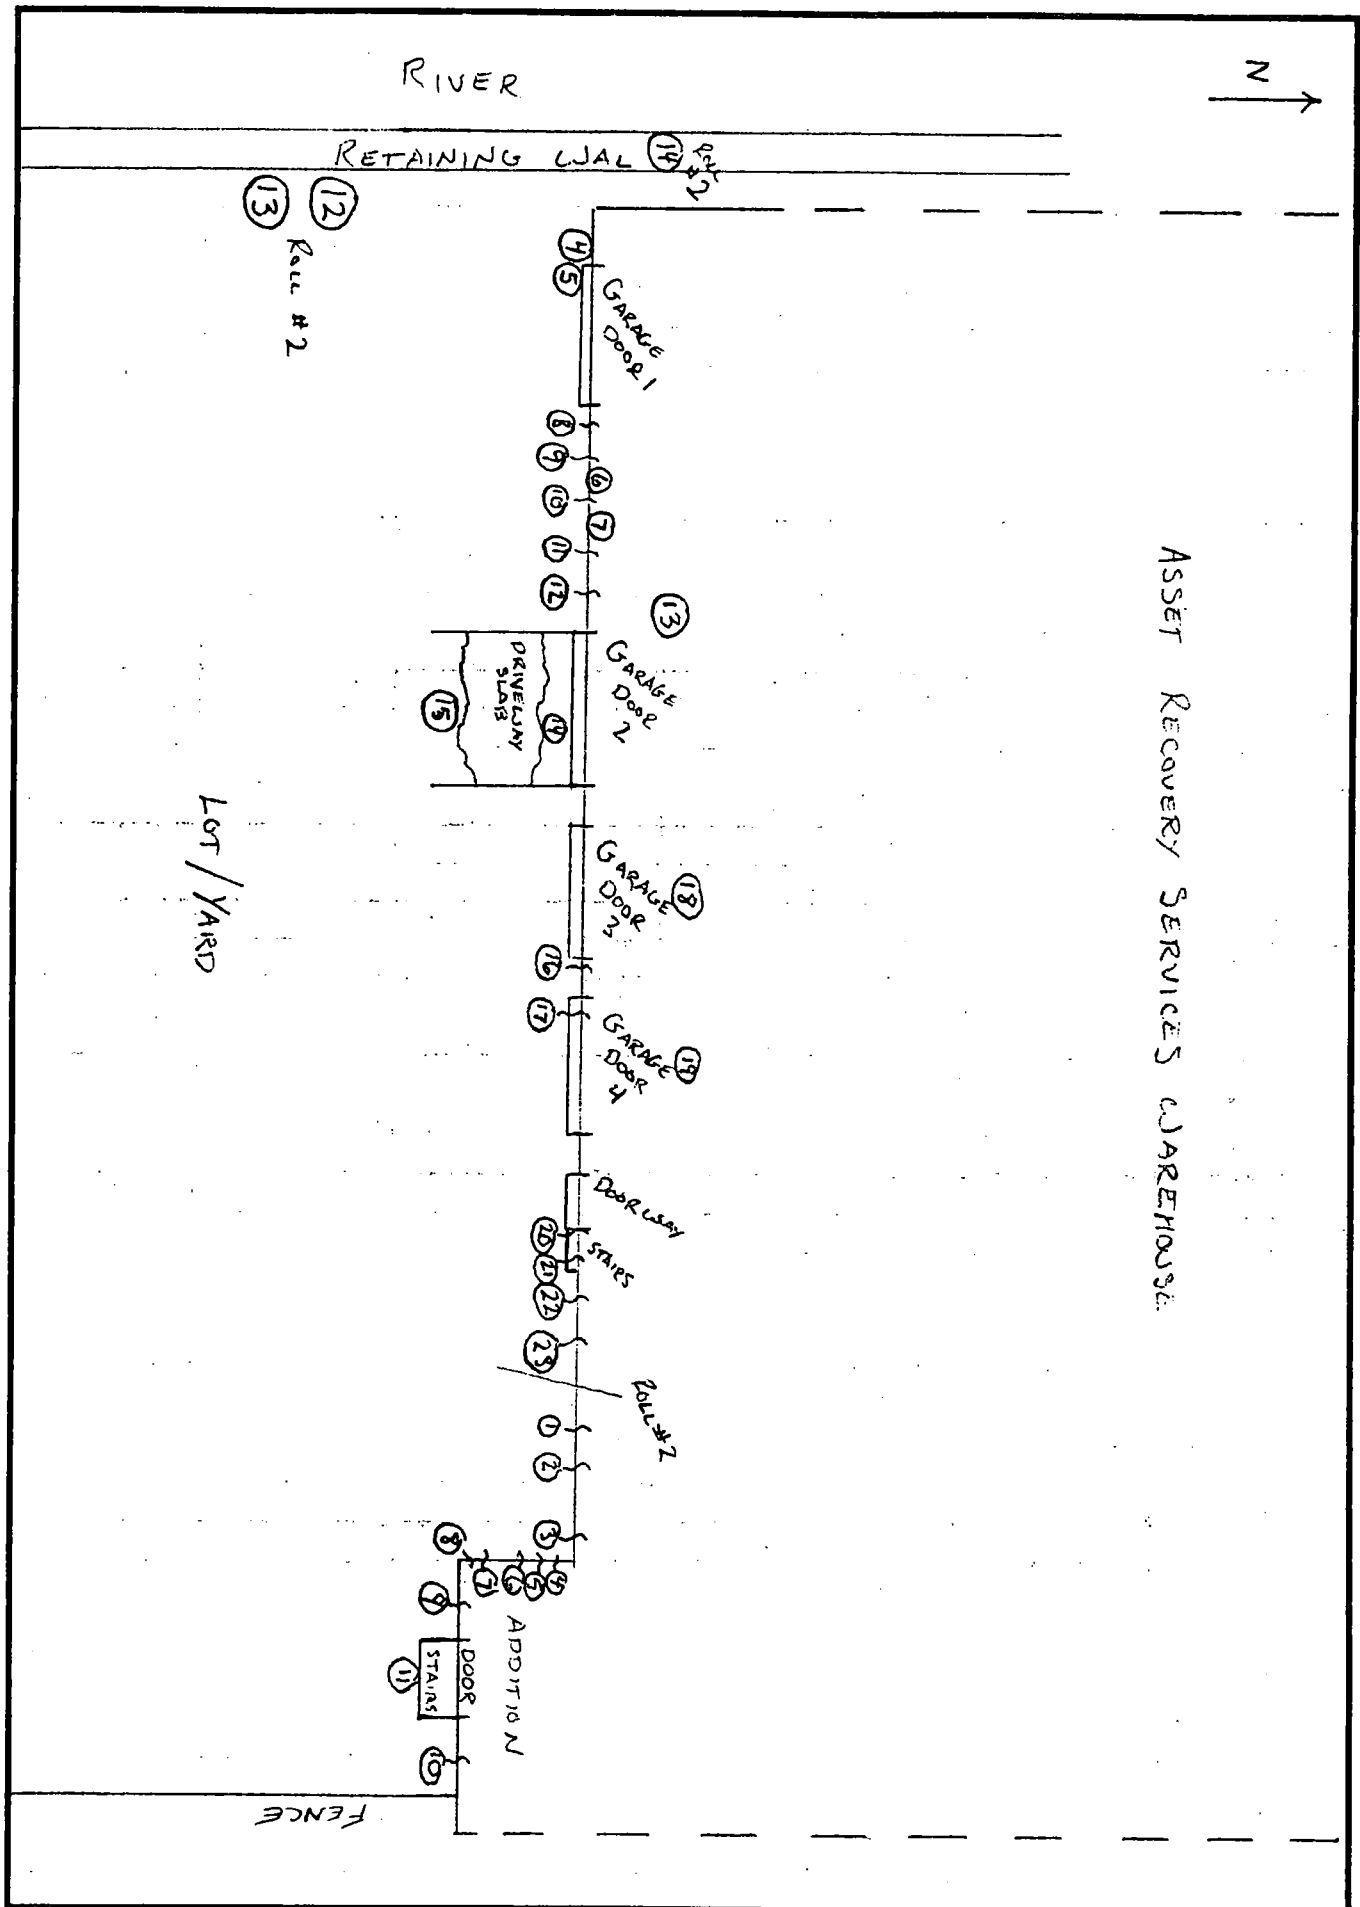
SHEET NO. 2 OF 3  
JOB NO. 0-1000

GUTTERS: YES ☒ NO ☐ COMMENTS: ONLY ON ADDITION  
 DOWN SPOUT: YES ☒ NO ☐ COMMENTS: ONLY ON ADDITION  
 D.S. DRAINS TO: EARTH ☒ THROUGH ☐ CATCHBASIN ☐ SEWER ☐  
 EROSION NEAR FOUNDATION WALL: YES ☐ NO ☒ COMMENTS: \_\_\_\_\_  
 BUILDING SETTLED: YES ☒ NO ☐ COMMENTS: SOME H.L. CRACKS IN FOUNDATION WALL
